Variation of Natural Frequencies for 3F Wooden Structures in Fresh, Damaged and Reinforced States

SONGTAO XUE^{1,2}, JUN OKADA¹, TOSHIMITSU HAYASHI¹ AND HESHENG TANG^{1,2}

ABSTRACT:

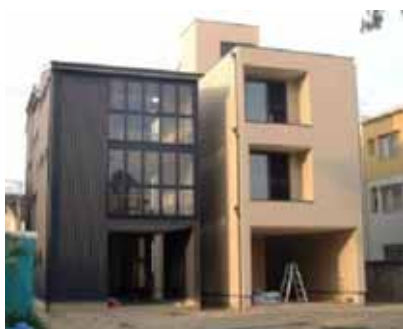
Fig.1 Real wooden frame building

In 2001 we have built two buildings in the campus of Kinki University, wooden material, three stories, one traditional construction method and one newly developed method. The purposes of the two buildings are to predict possible recycle material rate after five years use. And thus these two buildings will be destroyed at the end of 2005, to check the recycle rate. In the same time we will take vibration experiments, which will certainly predict the variation of the natural frequency while one or more columns or beams will be cut off. The two real three-story wooden frame buildings are shown in Fig. 1. The right one is used for our tests. The wooden frame building consisted of sills, beams, columns with different rectangular cross section sizes, wood floor plates and wood shear walls. The sills, beams and columns were properly connected to form rigid joints. Overall dimensions of the building were measured as 10.942m×4.55 m×8.715m (Fig.2). We made our tests under the following conditions: manmade pushing was added to roof of the building considering the initial displacement load of the structure. Each building floor was equipped with two accelerometers (one is wire sensor the other is wireless sensor) in the x direction.

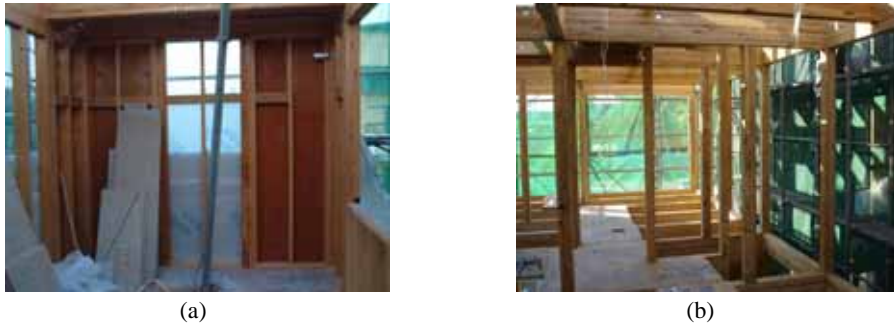
Case 1: Wall and floor plates are removed step by step (D_f_w).

(a) (b)
Fig.3 Wall and floor plates removed cases (D_f_w)

To simulate different damage cases of structure, the wall, floor plate, beam and column were removed. The damage severity is simulated by removing each floor plate, wall, beam and column step by step during experiments. To simulate reinforcement, the removed columns will be replaced by braces. These braces were jointed with sill/beam and column. The reinforced structure has two braces in the wall of the first and second stories. Fig.3 shows the damage case of the wall and floor removing. Fig.4 and Fig.5 show the damage case of the 2nd floor's beam removing. To fully utilize removing or adding of the column and brace for generating different damage and reinforcement patterns, the three columns and four braces in the first floor and the second floor were removed or added either simultaneously or successively during the experiments. The configurations of the columns and braces of one side as shown in the Fig.6, the other side is same. Symbols D_f_w (floor and wall are removed), D_b (beam is removed), D_c (column is removed) and R_br (brace is added) are used hereafter to represent the different damage cases and reinforcement respectively. Settings of simulated damages and reinforcements are described as fellow.

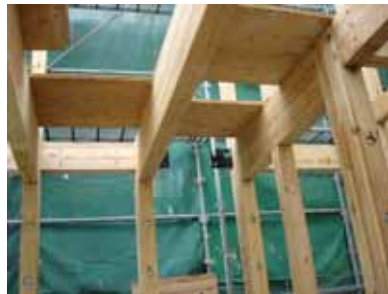
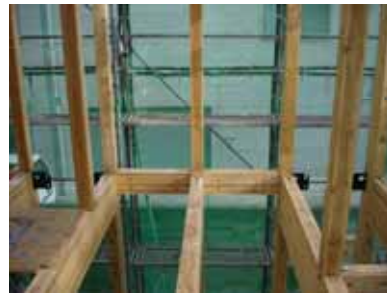
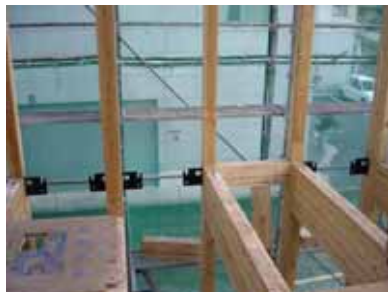
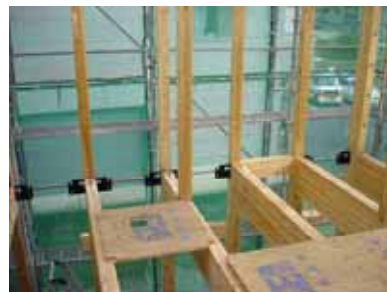
Case 2: Beams of the second floor are removed step by step (D_b).

Fig.5 The 2nd floor's beams removed cases (D_b)

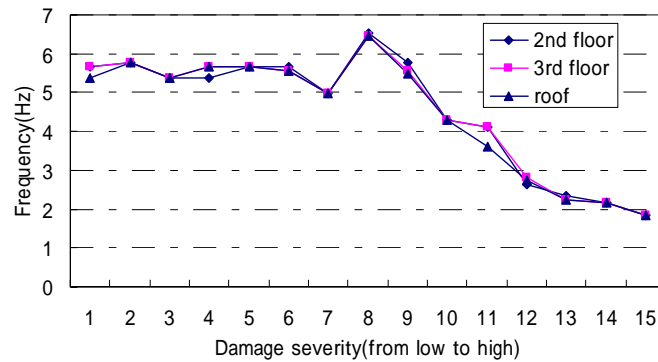
The change of natural frequencies of the building with different damage cases was also calculated, and the results are given in Fig.7, Fig.8 and Fig. 9. It is seen from Fig. 7 (case 1) that even if the degree of damages increases, the natural frequency remains unchanged or increased. Various environmental factors can alter frequencies without damage, because we took this test in many days. Statically indeterminate condition and mass reduction of this building also can lead to this phenomenon. Hence, data from instrumented structures have clearly shown that changes in natural frequencies are not

Fig.7 Experiment Results of the wall and floor removed cases

always a reliable indicator of damage because various environmental factors can change frequencies without damage. The changes in natural frequencies, a commonly used criterion for damage detection, are not always a reliable indicator of damage. Differ from the case 1, Fig.8 (case 2) shows that parts of the building damaged, the stiffness will decrease, which will cause the decrease of the first natural frequency. Fig.9 shows the results of the case 3. Theoretically, the frequencies of stages 2, 4 and 7 should be same; stages 3, 5, and 8 should be same; stages 12 and 18 also should be same. Because there have same physical mechanic conditions each other. Unfortunately, the Fig. 9 clearly shows different results. All these examples indicate that the changes in natural frequencies alone are not sufficient to reach conclusions about damage.

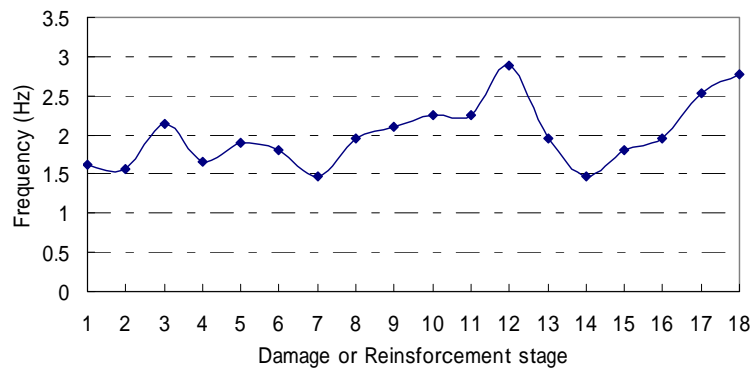
Fig.9 Experiment Results of the column removed or brace added cases (D_b&R_br)

The damages and reinforcements have been obtained by removing the walls, floor plates, columns and beams and adding the braces step by step. Data from instrumented structures have clearly shown that changes in natural frequencies are not always a reliable indicator of damage because various environmental factors can change frequencies without damage. The changes in natural frequencies, a commonly used criterion for damage detection, are not always a reliable indicator of damage. Various environmental factors can alter frequencies without damage.
