Feasibility study of impact damage detection for CFRP structure by Lamb wave sensing using FBG/PZT hybrid system

ABSTRACT:

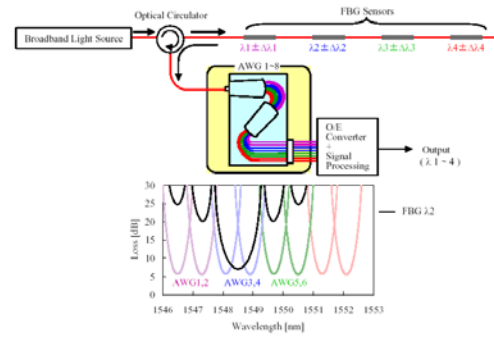
Figure 3. Configuration of an AWG-type filter

Figure 1 shows a schematic of the basic damage monitoring system [5–7]. In this newly developed system, a piezo element functions as the actuator for elastic wave excitation while an FBG optical fiber works as the sensor (receiver). The detection principle of this system is based on the energy change of the received waveform. If a damaged section exists in the path of the elastic wave, the energy of the elastic wave will change. By detecting this change, the system can detect the damage to a composite structure. Figure 2 shows the damage monitoring system for an inaccessible critical region (hot spot) in a wing box structure in which the sensor and actuator are positioned. Commercial FBG sensor systems are capable of detecting elastic waves with a frequency of several dozen kHz. However, their capability for damage detection is not satisfactory. Hence, we adopt an AWG-type filter; this is highly sensitive to the displacements in the FBG gratings with microvibrations from strains due to an elastic wave launched from the PZT elements. Figure 3 shows the configuration of the AWG-type filter.

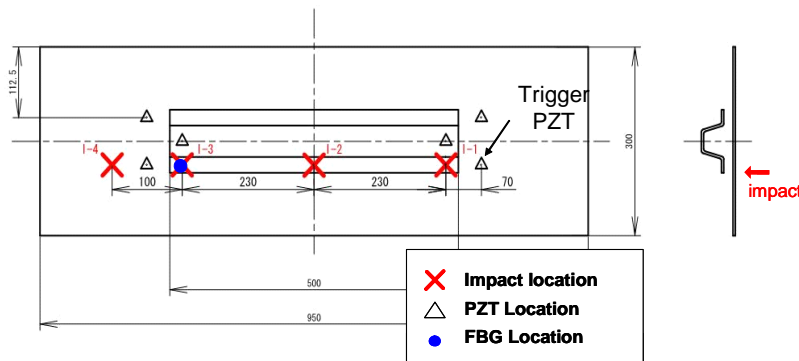
Figure 4. Setup of the impact detection experiment

We prepared a structural element test specimen that simulated the skin/stringer bonding parts of an aircraft structure, as shown in Figure 4. The specimen consisted of a CFRP skin/stringer structure with 16 ply $[+45/0/-45/90]_{2s}$ quasi-isotropic laminate. Impact loading was carried out by hammer hitting on the static without any forced restriction. However, the impact load was not assigned a specific damage level. Further, the impact load was located on the opposite side of the bonded stringer surface. The actual impact locations were four, as shown in Figure 4.

It is necessary to use the delay in the arrival time of the elastic wave received by more than three FBG sensors and the trigger from the PZT element for the identification of an impact location. In this study, when we assumed an impact location at I-3 in Figure 4, the received elastic wave at the bonded FBG sensor with a small diameter is shown in Figure 7. From the results, it was confirmed that the time difference of approximately 0.34 msec was caused by the delay in the arrival time of the elastic wave. Therefore, the spread speed of the elastic wave was approximately 1.5 km/s because the spread distance during this period was 530 mm. However, this speed was somewhat low in comparison with that (A0 wave: 4 km/s, S0 wave: 8 km/s) calculated from the material stiffness of the specimen.

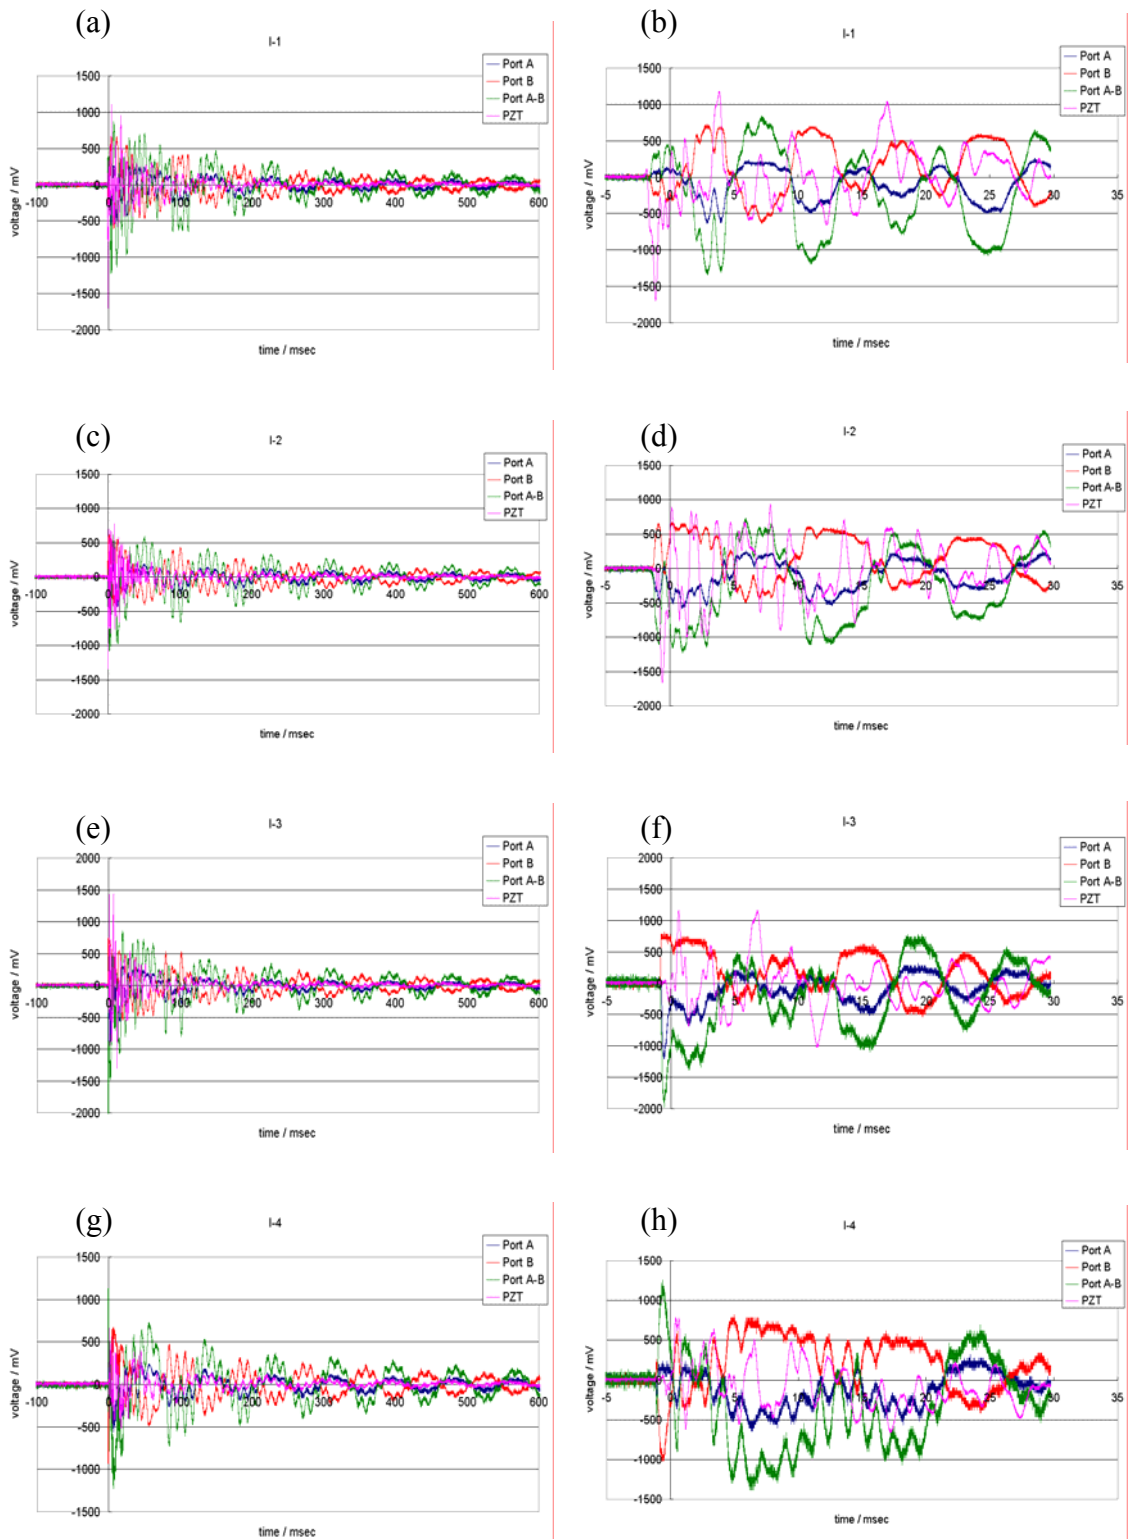
Figure 6. Output waveform of FBG sensor No. 3 after impact loading (standard/bonded)

Figures 5 and 6 show the received waveform and the enlarged figure of the waveform of the elastic wave when we changed the impact position of FBG sensors No. 2 and No. 3. All the FBG sensors were available for elastic wave detection. In particular, FBG sensor No. 3 (normal diameter, gage length: 10 mm) showed the largest output among the three kinds of FBG sensors. On the other hand, we compared the performance of the FBG sensor with a small diameter for both the embedded and bonded cases. An embedded FBG sensor resulted in a large noise and small output signal when compared to a bonded FBG sensor. However, this depended on the intensity of the optical power and the embedded position. The waveforms generated by the impact showed a complexity in their initial part (0–50 ms). However, they showed a regular pattern after 50 ms. Further, it was not always same things that the received waveform by PZT which we used as a trigger of a measurement beginning. In this feasibility study, we observed that signals from ports A and B were not symmetrical waveforms. It was assumed that this was because two reflection spectra chosen by an AWG filter were not displaced with regard to symmetry for the center wavelength of the FBG sensor.

Furthermore, when we change the travel distance of the elastic wave by changing the impact location, the amplitude of the received waveform is not considerably attenuated. From these test results, it is expected that a long gage and bonded FBG sensor are suitable for impact detection by the abovementioned process.

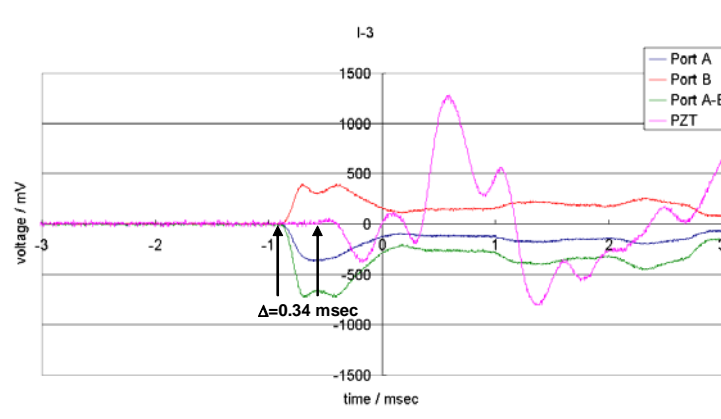
Figure 7. Time delay measured by using the elastic wave received by FBG No. 3 (small/bonded)

Thus, it was confirmed that impact detection was possible by observing the delay in the arrival time of the received elastic wave.
