Fiber optic sensors for SHM of bonded repairs in composite structures

ALFREDO GUEMES

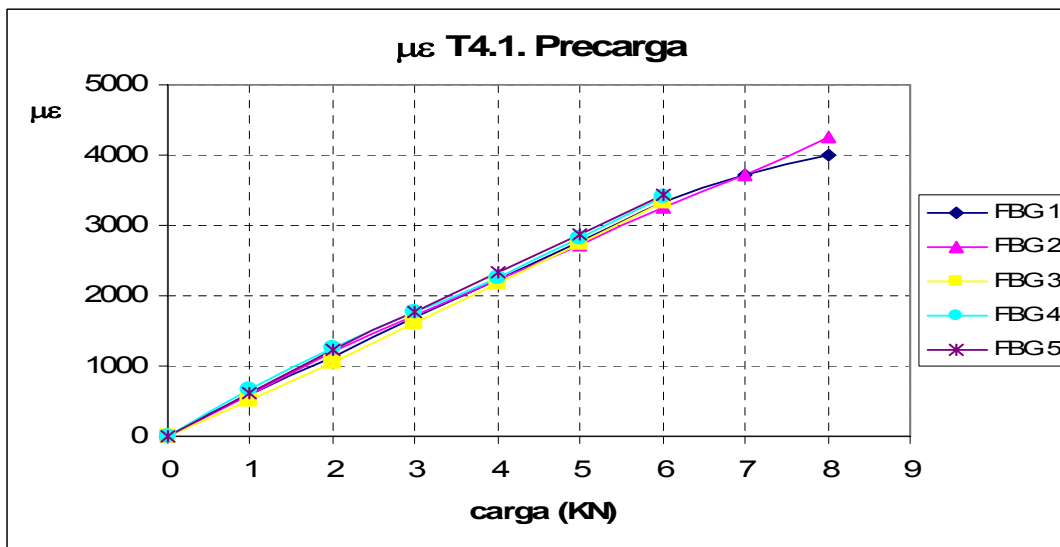
Figure 4. Peak displacements :VS. Tensile Load

The figure 3 shows the original spectrum; FBG 1 was not embedded in the bondline, to serve as temperature sensor during the cure of the patch. Later on, it was bonded with cianoacrylate to the parent laminate. The peaks displace with the applied load, fairly linear as expected, without significant differences among them, neither among the reference or the defective specimens (figure 4). There was a significant drop in the height of the reflected peaks (fig. 5) with the applied load, due to microbending at the consecutive steps, because the connector was placed at FBG 1 side (a loss of 3 dB is equivalent to halve the reflected power). After 6 kN, approximately 50 % of the failure load, the spectrum change dramatically, and the peaks after FBG1 decrease near to zero.

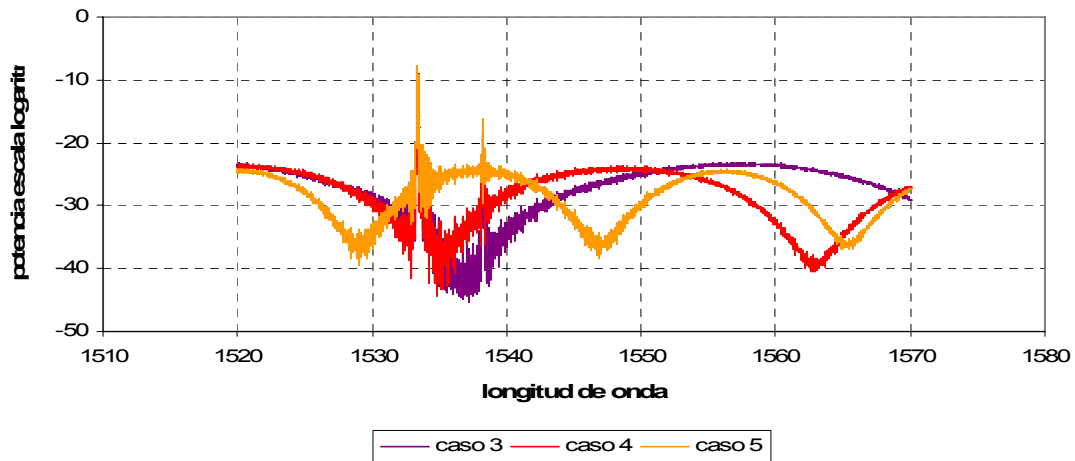
Figure 6. reflection spectrum after internal fiber breaks, with spontaneous F-P

Evidence of internal Fabry-Perot effects, associated to fiber breaks, was found by a progressively stronger waviness that masks the embedded FBGs (fig 6)

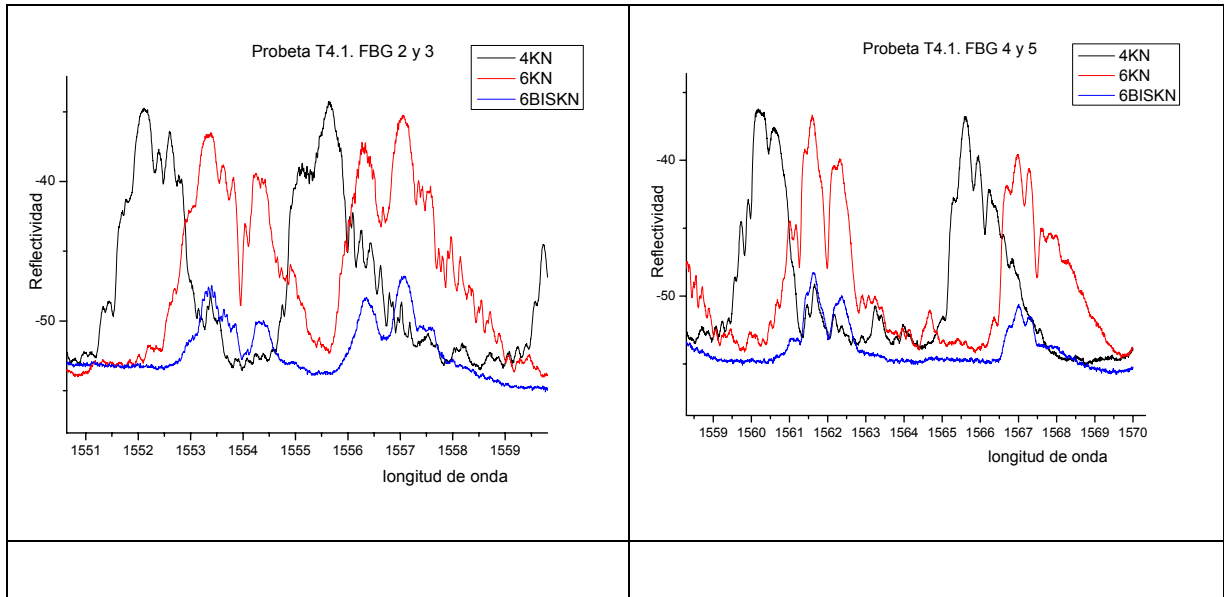
Figure 7. Spectral distortion under loads for embedded gratings

It has a very significant effect on the spectral response. In our tests, one of the gratings (FBG1) was not embedded, but remained free, and was later bonded to the parent laminate during the mechanical tests by cianoacrylate. Consequently, we could expect a behaviour free of transversal effects, and consequently without distortion of the spectrum. Nevertheless, the experimental finding is a spectral distortion not identical but similar to that shown in figure 7.

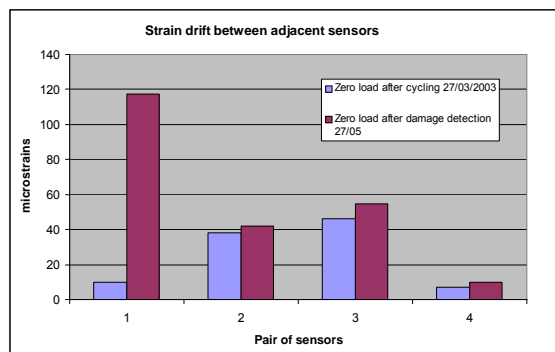
Figure 11. Drift of $117,5 \mu\epsilon$ between the pair of sensors closer to the delamination

After a first test series including loading-unloading cycles, damage did not appear at the monitored repair patch, and bonded sensors did not showed significant spectral distortion. After a second test series, a damage event happened (debonding in the right lower corner of the patch); then, measurements at zero load condition was done, and significant results have been obtained. A relative drift of $117,5 \mu\epsilon$ has appeared between the pair of sensors that are closer (2 cm) to the delamination. The pair of sensors FBG2, which were only 10 cm away from the corner did not detect the crack. It is confirmed the local character of the perturbation. The new distributed sensing technique as BOCDA [7], offers an alternative solution to the FBGs to cover the full envelope.

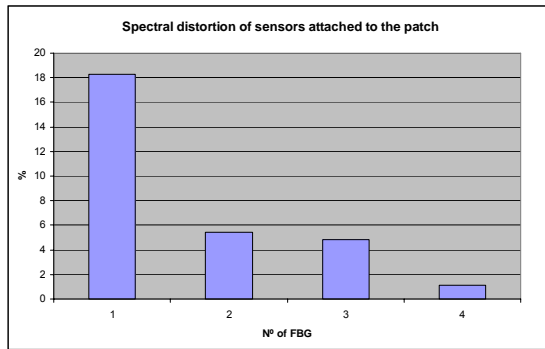
Figure 12. Spectral distortion in the grating bonded on the patch

Additionally, a spectral distortion of 18% has been detected in the FBG II, the grating bonded in the surface of the patch closer to the debonding. These results seem to confirm the capability of these techniques to detect perturbations in the near stress/strain fields promoted by debondings/delaminations.
